***In situ* Characterization of Trans-laminar Fracture Toughness using X-ray Computed Tomography**

Xiaoyang Sun^a, Shin-ichi Takeda^b, Michael Wisnom^a, Xiaodong Xu^{a*}

Abstract

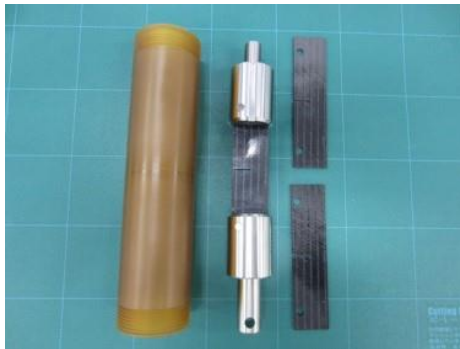
b) Test rig assembly

The ESET specimens were loaded on to the test jig inside a polymer tube, loading pins were inserted into the two holes at each end of the specimen, as shown in Figure 1 b). The whole loading tube assembly was then installed on the test jig and was brought closer to the radiation source during CT scanning, as shown in Figure 2 c). The CT scanner used was a Shimazu's inspeXio SMX-225CT FPD HR with a customized *in situ* test rig. The *in situ* CT scans were conducted at JAXA. The test was displacement controlled.

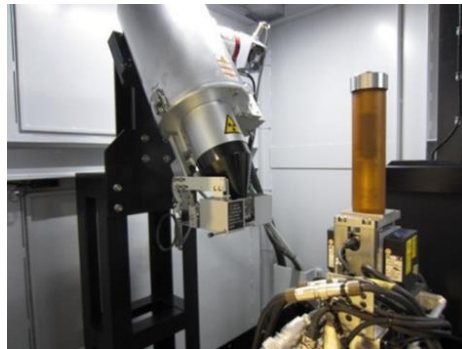
c) Test jig set-up for scanning

Figure 1. *In situ* CT scan specimen and test set-up.
